Explosion in a nitrogenous fertiliser plant

21 September 1921

Oppau – [Rhénanie]
Germany

Chemical industry
Disaster
Ammonium Sulphonitrate
Victims
Material damage
Modifications

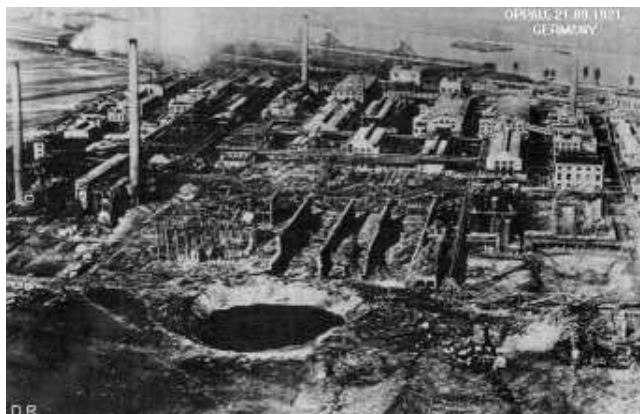
On 21 September 1921, when the technician was preparing the holes for the firings in the "silo 110" at 7.00 am, a very powerful explosion took place in the silo at 7.32 am, creating a 90m X 125m crater and 20m deep!

According to witnesses, there were two successive explosions, the first one being weak and the second one devastating. Seismographic readings from Stuttgart, at 150 km from Oppau also showed two distinctive explosions that occurred at an interval of half a second.

Soon after the explosion, there were multiple fires on the facility and other less intense explosions occurred on the site and the air was heavy with ammonia vapours.

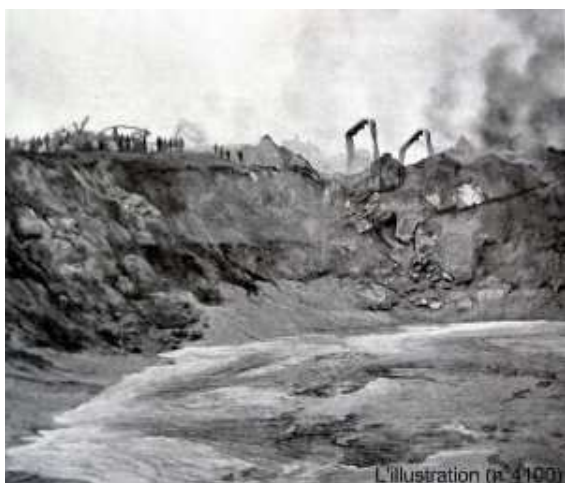
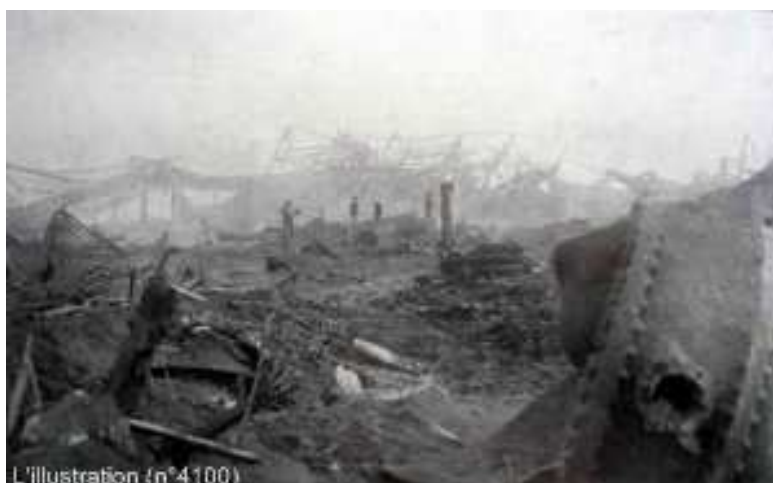
The official human casualty reported included 561 deaths, 1,952 injured and 7,500 people left homeless. Among the victims include passengers from three worker trains arriving on site for change of shift. Several children on their way to school were injured, boats on the Rhine river sustained damage with numerous sailors also injured. Eye injury was observed in several cases.

Around 80% of the buildings in Oppau were destroyed. Substantial damage was also reported in Ludwigschafen and Mannheim. Massive glass debris on the roads of Heidelberg (30 km from Oppau), interrupted traffic in the city.

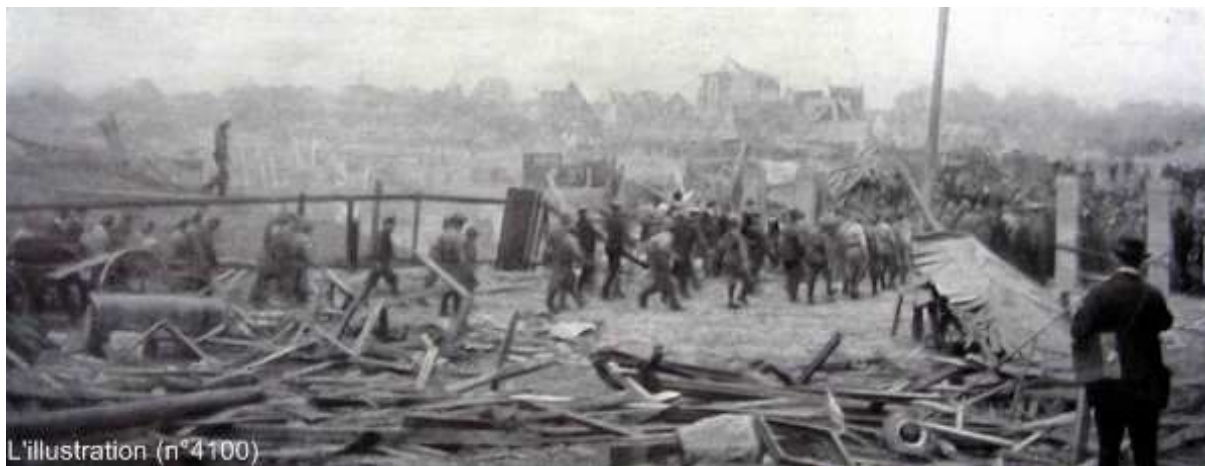
The extent of material damage and casualties made rescue operations particularly hard.

The emergency services that were rapidly alerted could not arrive on the site before 9.00 am out of the fear of new explosions. The French army based in Ludwigshafen and Mannheim created a safety line around the site. Emergency services (doctors, fire fighters, ambulances, French and German red cross volunteers, army, etc.) arrived from the neighbouring cities. Private and public vehicles were requisitioned.

The emergency hospitals based in Ludwigshafen were full-up very soon and the injured had to be moved to Mannheim, Heidelberg, Frankenthal and Worms. The homeless were accommodated in schools, sanatoriums or in families living in neighbouring towns. Many however refused to leave their destroyed homes.
